HOW TO INSTALL A SCOTT DRAKE UNDER-DASH WIRING HARNESS ON AN EARLY MUSTANG

Author: Mike Magda | 07/06/2021 < Back to Motor Life Home

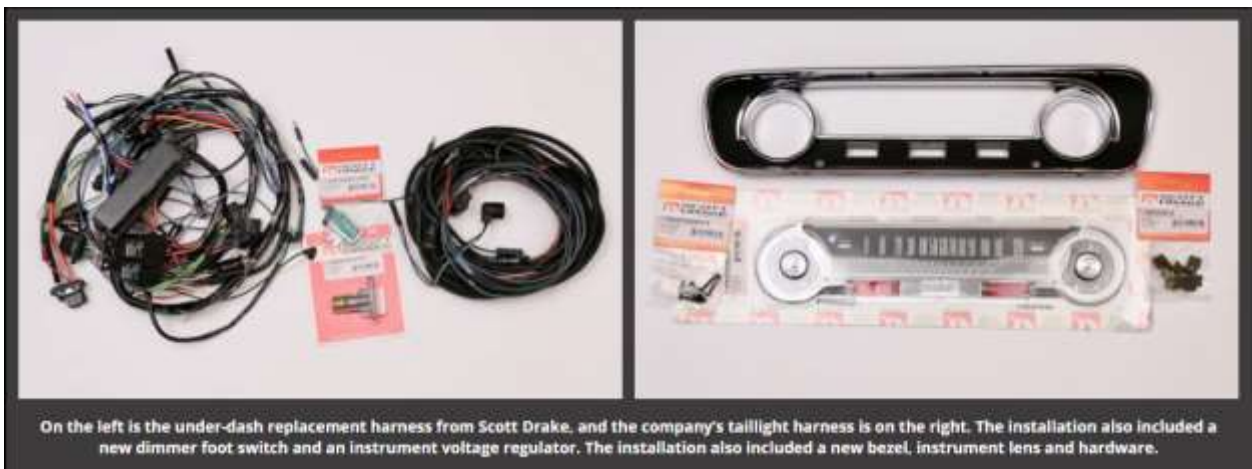
Consider the condition of this 1965 Ford Mustang fastback. The most noticeable problem to the owner was the high beams not working. But the owner had installed and removed an 8-track player and CB radio in the '70s in addition to swapping out three different radios and adding stereo side speakers. Not only was the harness aging and showing signs of wear, it had simply been hacked up too much.

Two summers ago, the 289 Hi-Po engine was rebuilt, and the under hood engine harness was replaced at that time. That left the under dash harness and the taillight harnesses that were still 56 years old and needing replacement.

While completely rewiring a vehicle from scratch can be an intimidating task, installing a replacement harness from Scott Drake is rather straightforward.

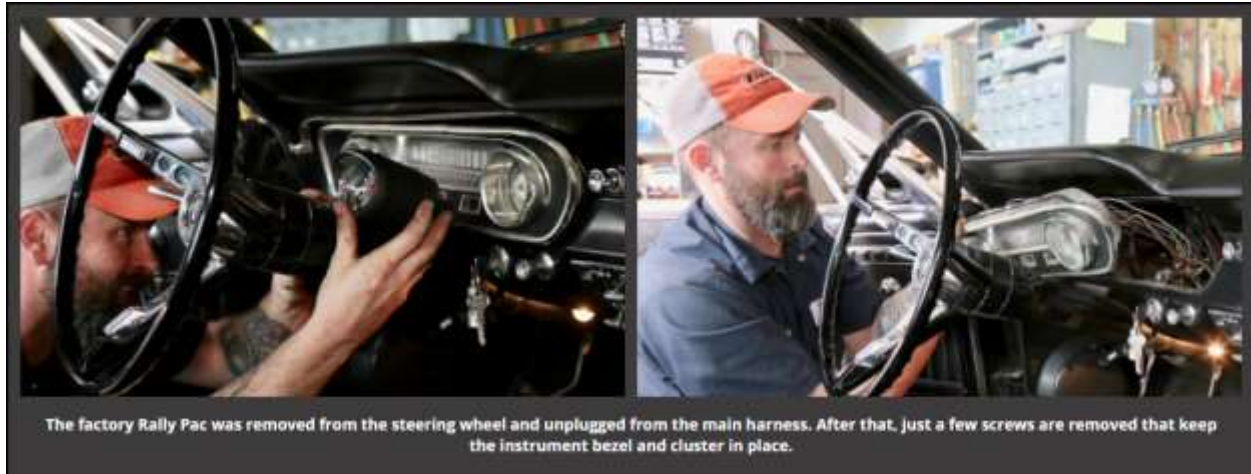
Making the job even easier is the Scott Drake replacement harness that not only matches up with the stock harness in appearance and color coding, but it comes with a modern 12-circuit ATC fuse block and relays to improve reliability. No more old style SFE glass-tube fuses; this new fuse block features conventional ATC blade-style fuses. There are also spare hot and keyed terminals in the fuse block for connecting new electrical components.

Each Scott Drake harness is specific to different Mustang packages from the early years, including 2- or 3-speed heaters and body styles. This Mustang had the 2-speed heater and needed the taillight harness engineered for the fastback.

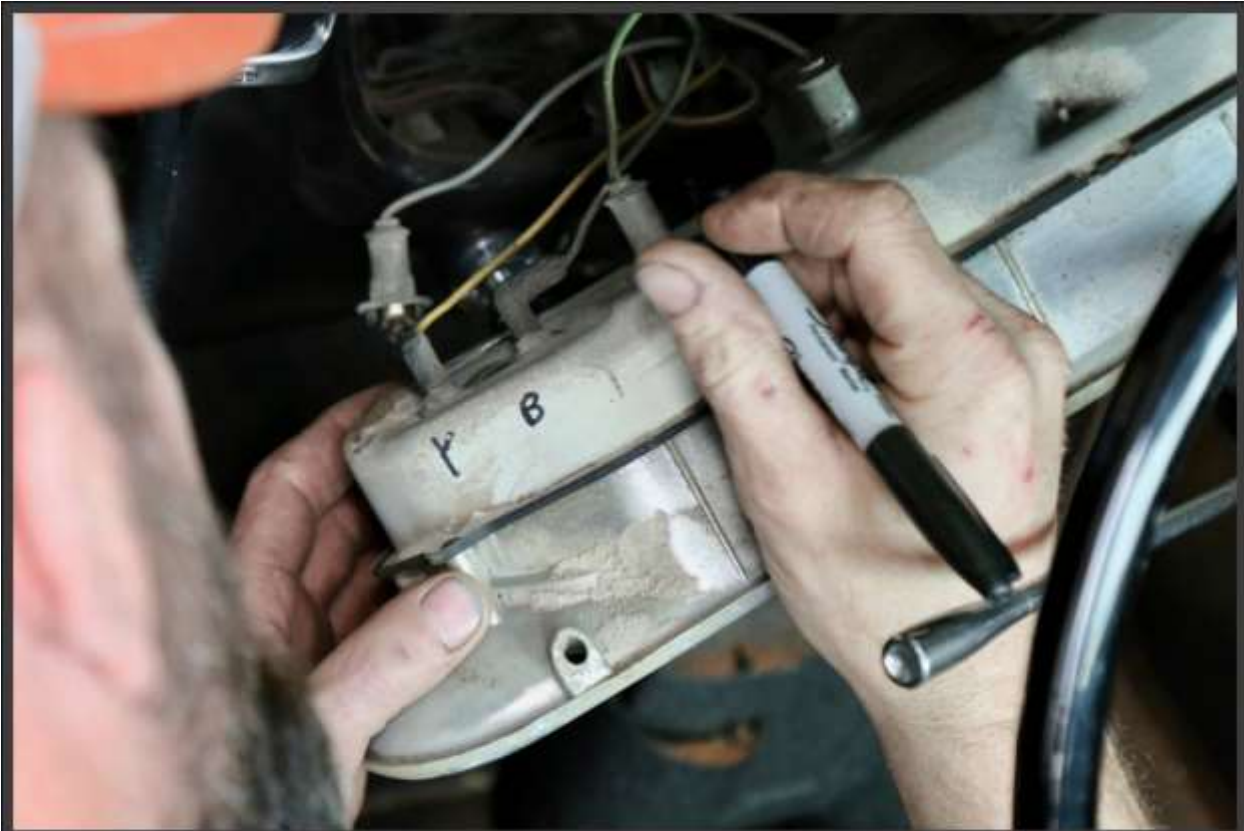
Using a permanent marker, Casey Barrett of Dakota Battery & Electric marks the wire colors and their position on the instrument panel housing. Note the worn and brittle condition of the wires and connectors.

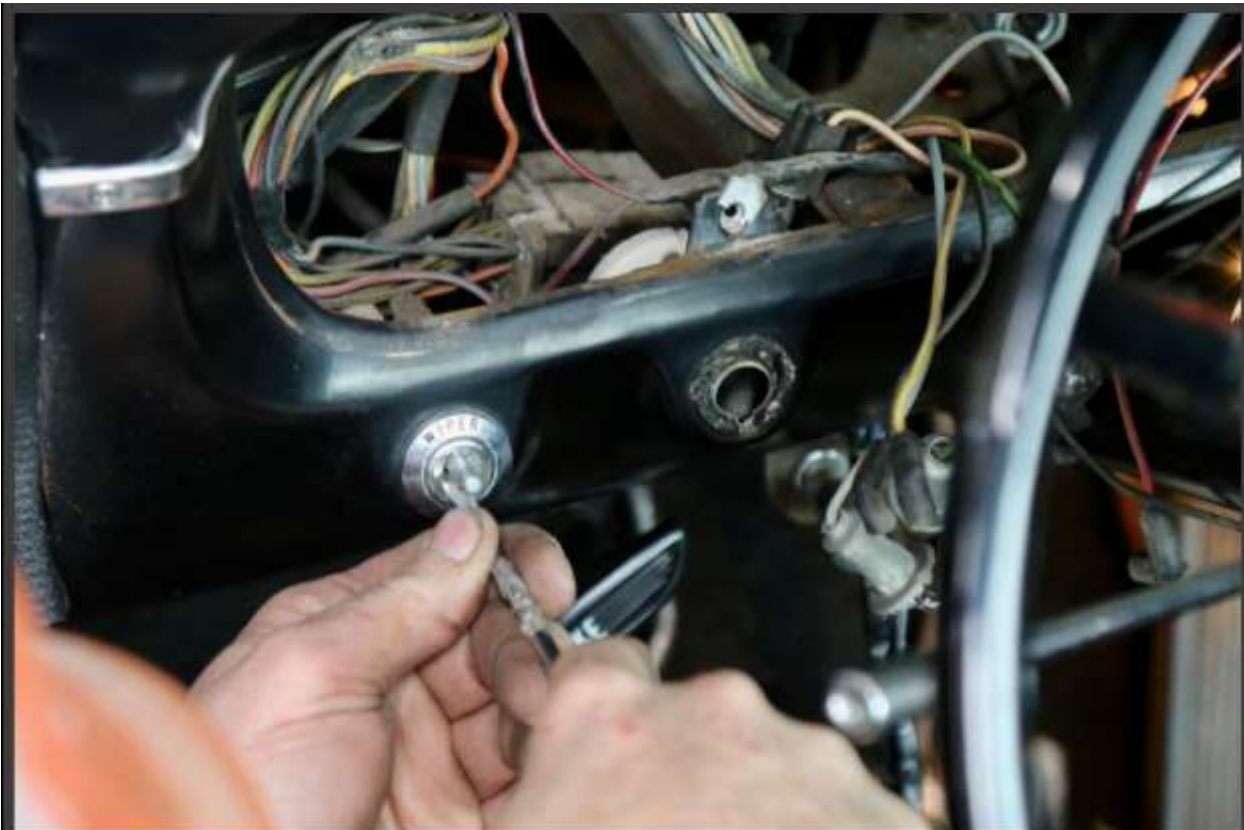
The disassembly continues by removing the wiper, headlight and other switches on the dash. Here, Barrett is using a small flathead screwdriver to turn and walk the internals out of the housing. Special tools are available to help remove or install some vintage switches.

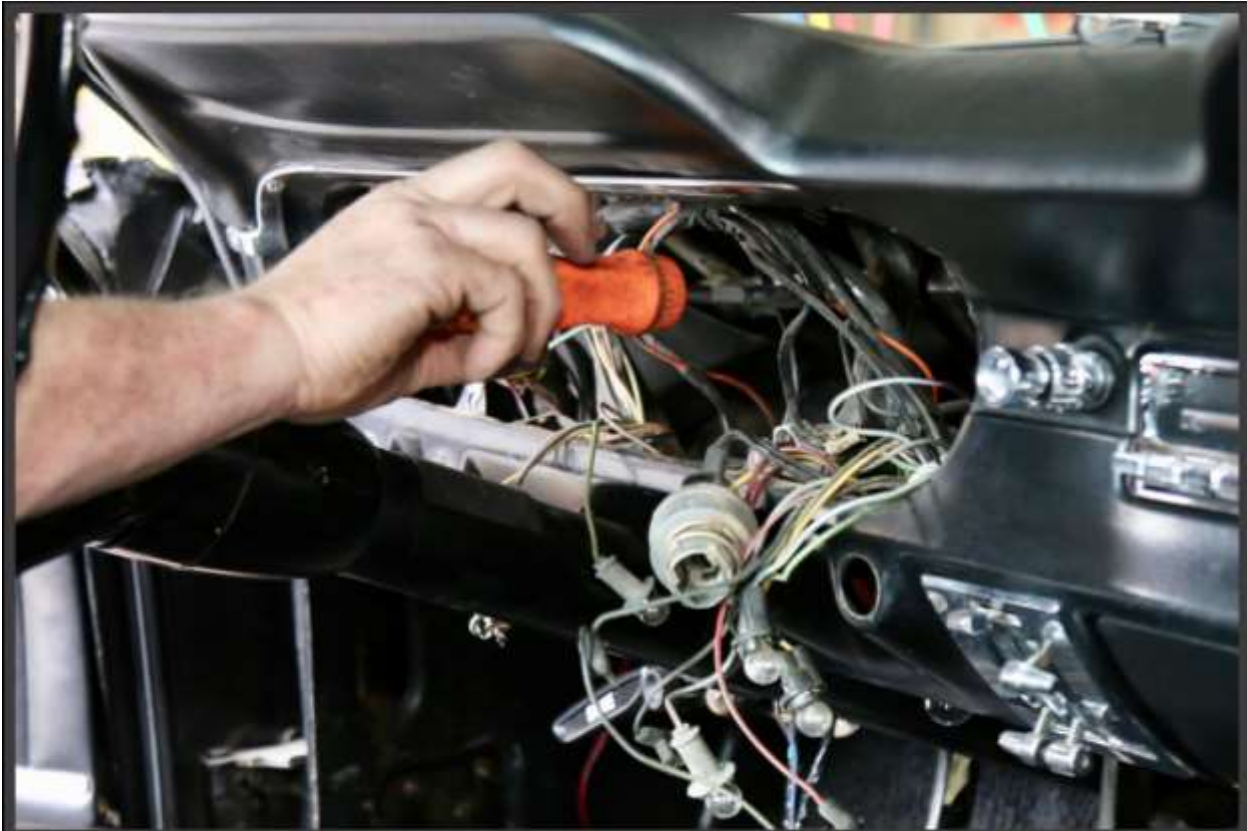
Pretty soon there's a spaghetti bowl of wires secured by a ground connection on a dash brace.

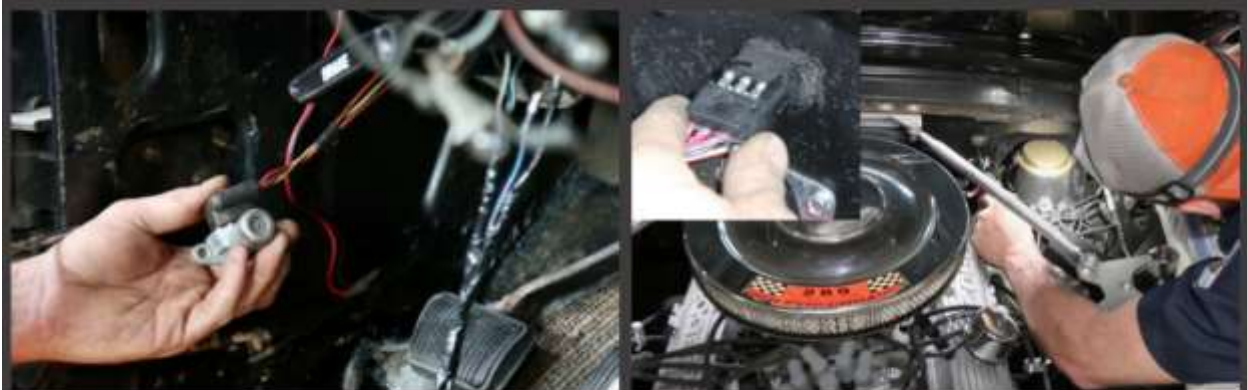
The high beams weren't working, so the floor-mounted dimmer switch was removed and disconnected. Note that the left sill plate and kick panel have already been removed, which also exposed the connection for the taillight harness down in the rocker area. The firewall plug leading to the engine harness is disconnected.

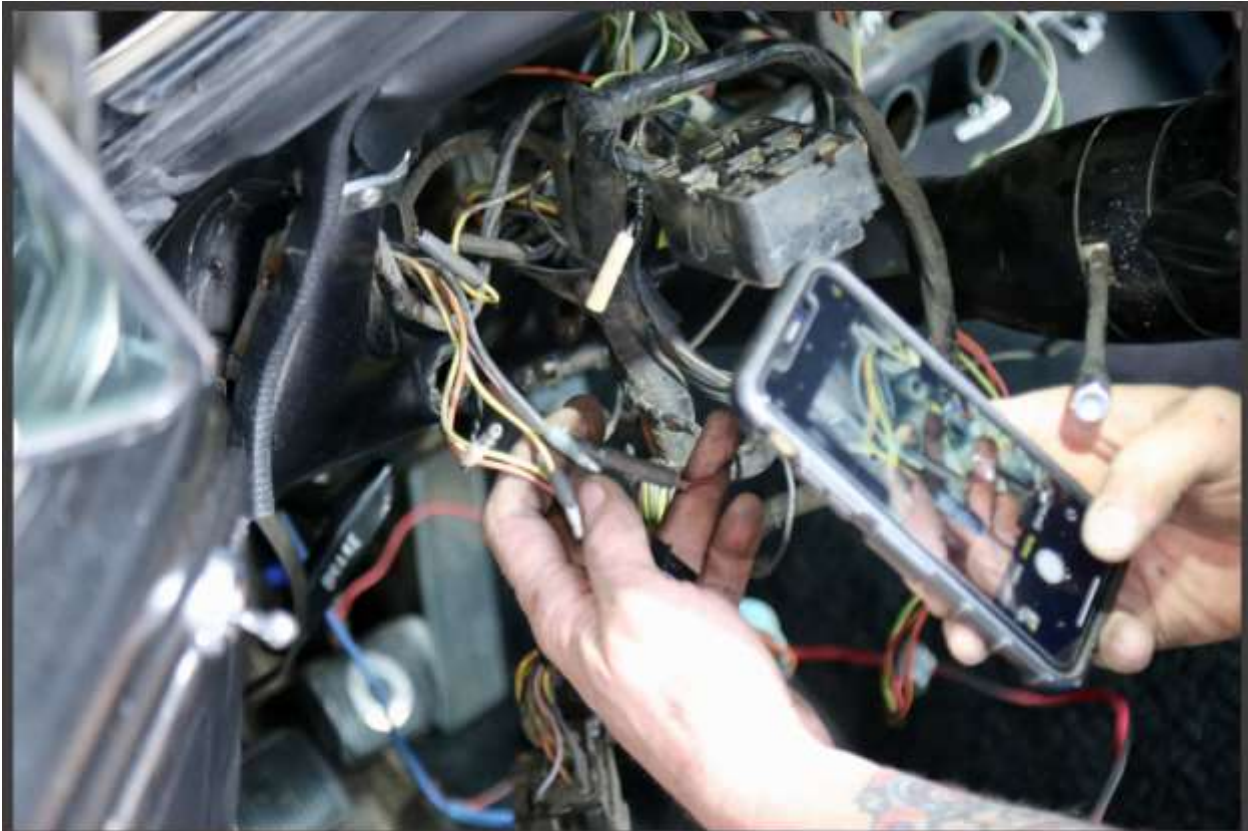
Barrett took cellphone photos of critical connections to help ensure correct hookups on the replacement harness.

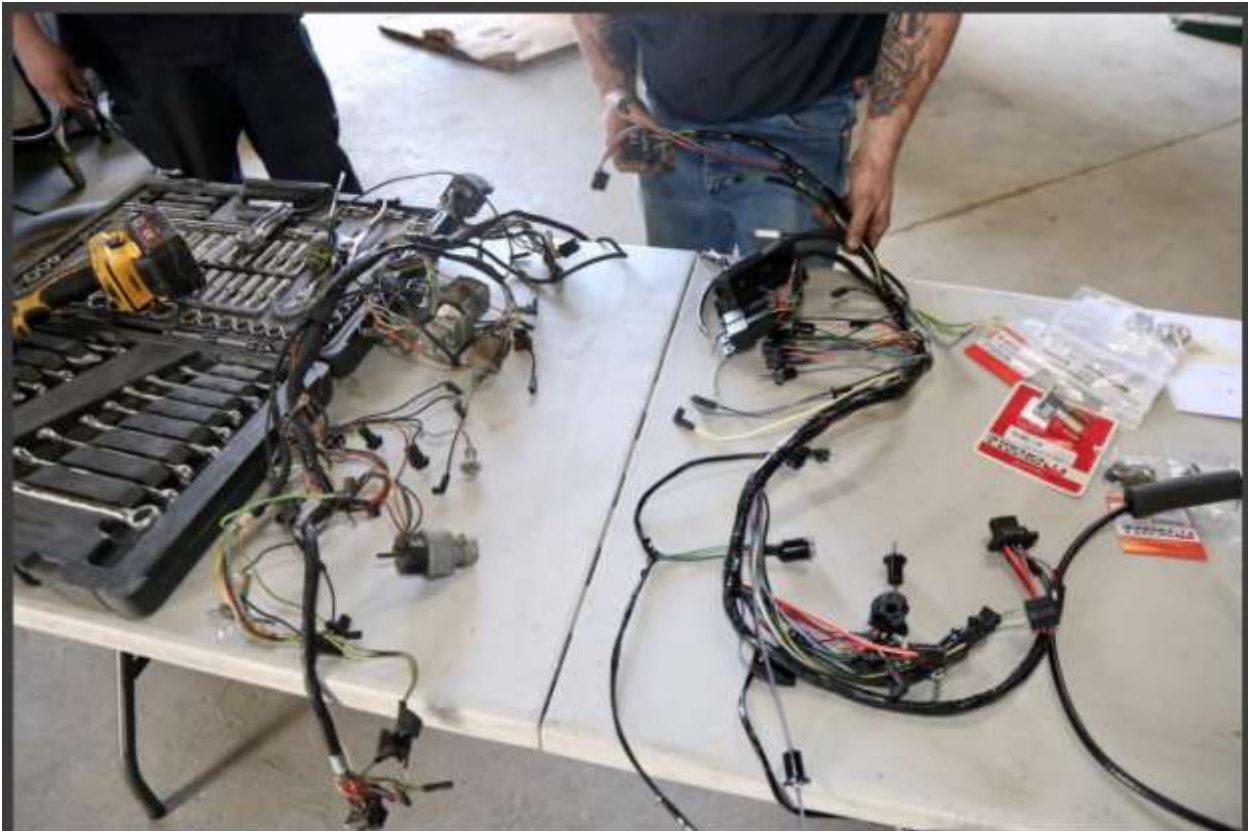
The old harness is compared to the Scott Drake harness on a large table. The type of connections and the colors of the wires were confirmed.

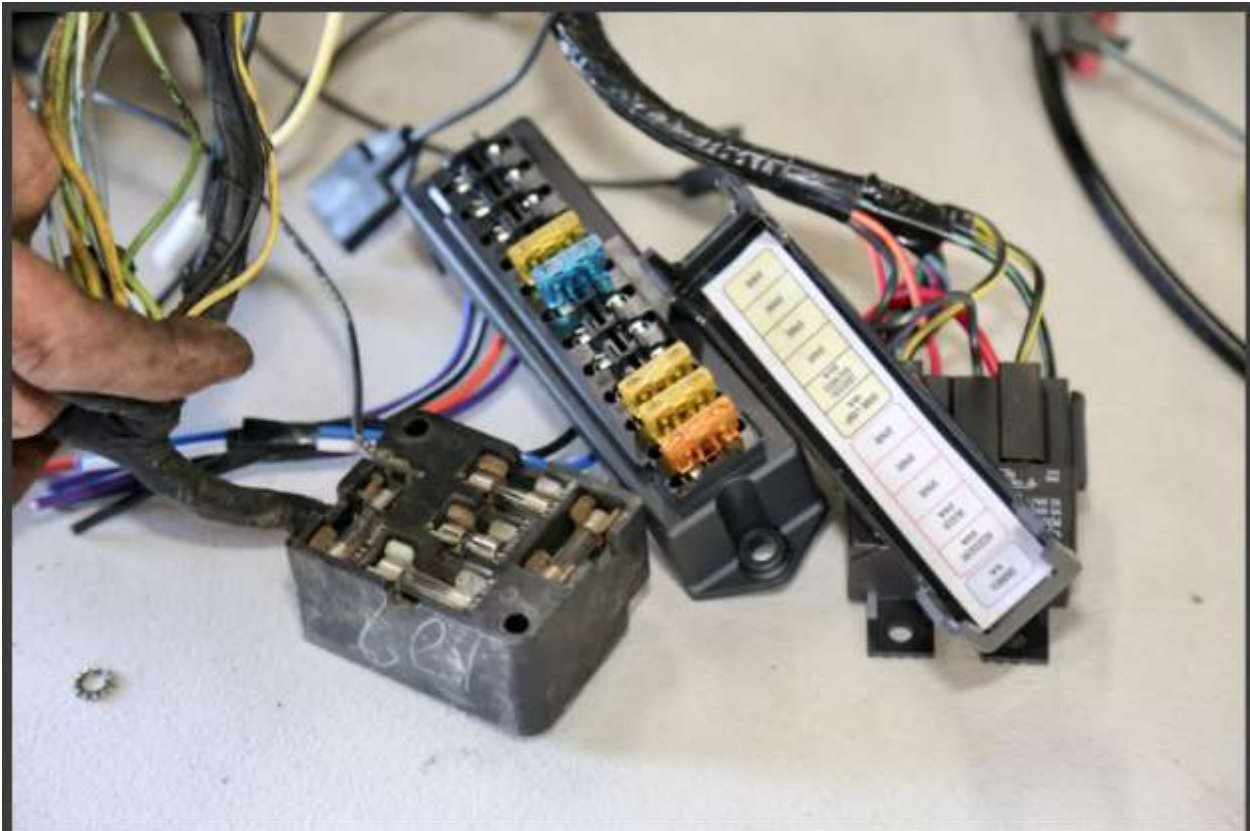
Here's a side-by-side view of the factory fuse box and the upgraded ATC fuse block in the Scott Drake harness.

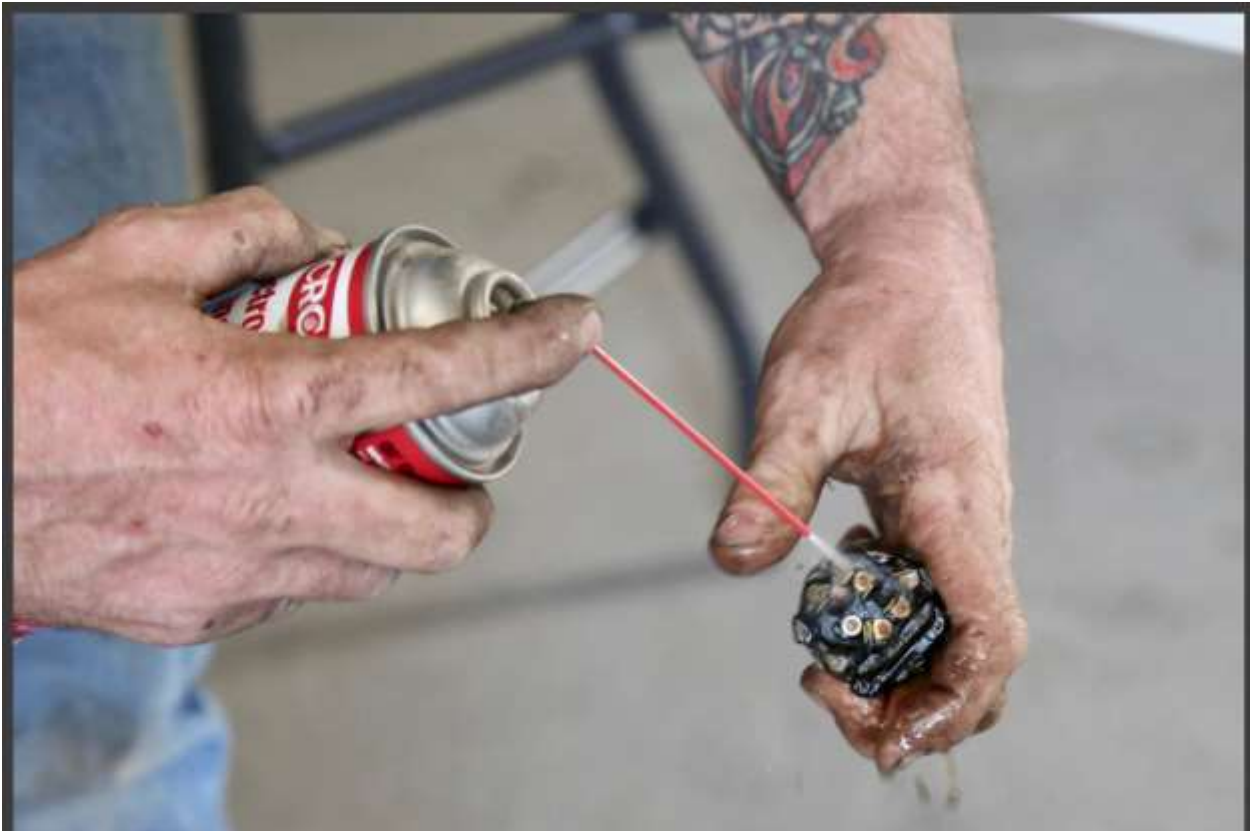
A couple of the switches were cleaned while others, such as the ignition and headlight, were replaced.

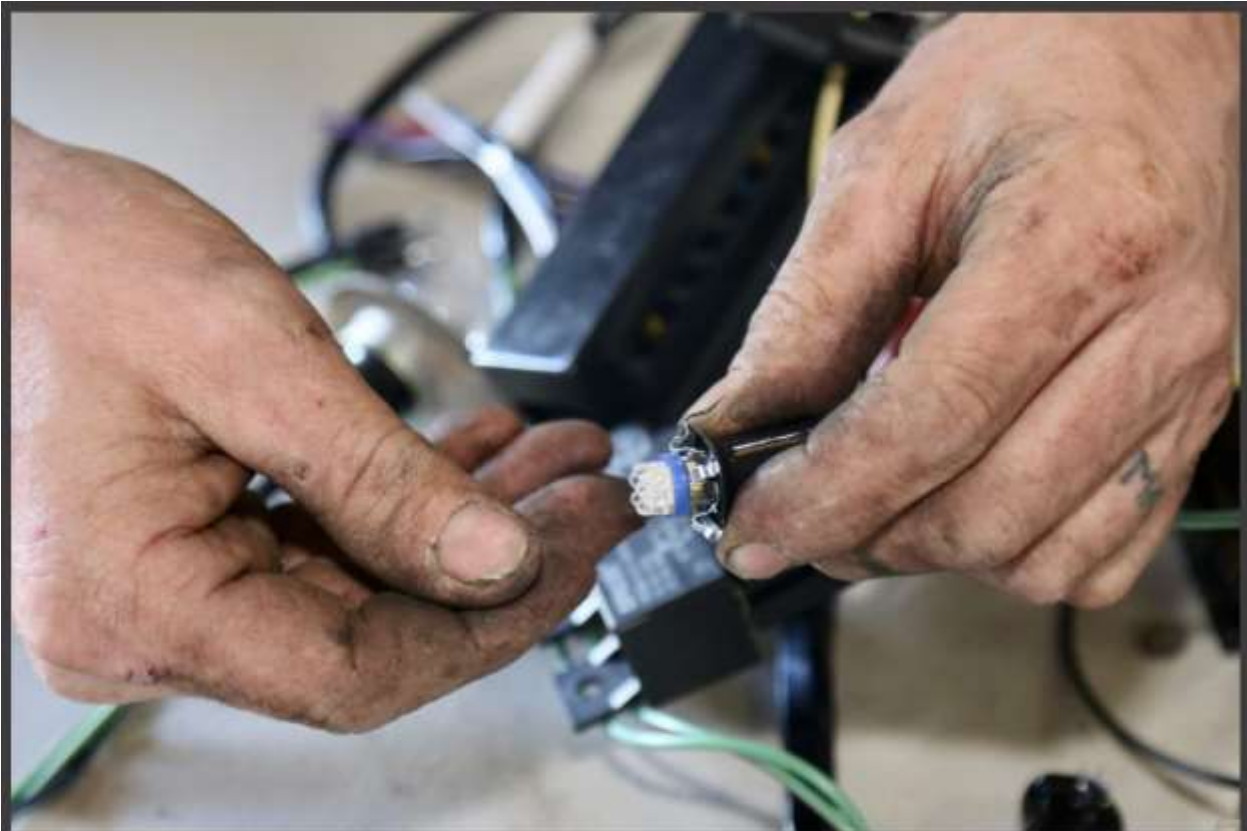
Some of the instrument panel lights were replaced with blue LEDs from Scott Drake. The alternator and oil warning lights were fitted with replacement incandescent bulbs because they are behind red lenses on the instrument panel. Also, the high-beam bulb was left incandescent because it's behind a green lens.

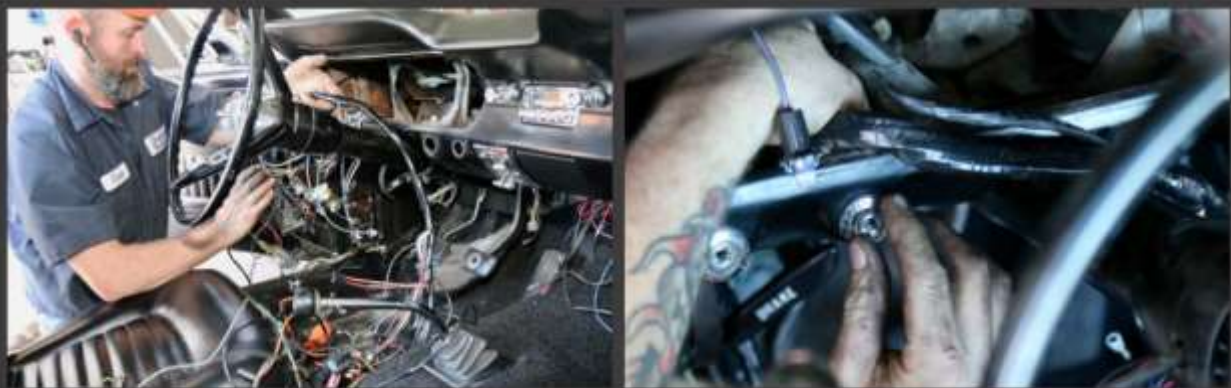
The new harness is carefully positioned over the steering to help facilitate the start of reconnecting the leads. Wires for the switches are identified and connected as the switches are installed.

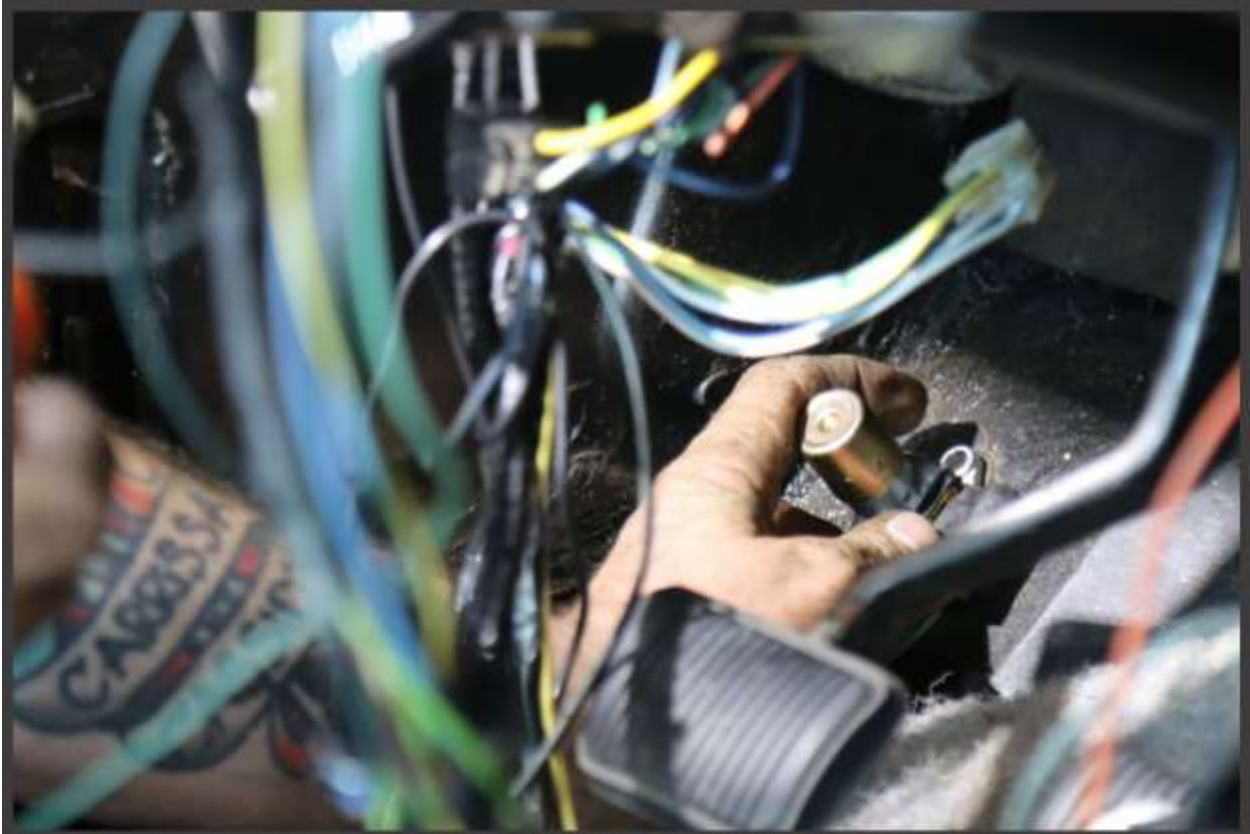
The new Scott Drake dimmer switch is installed.

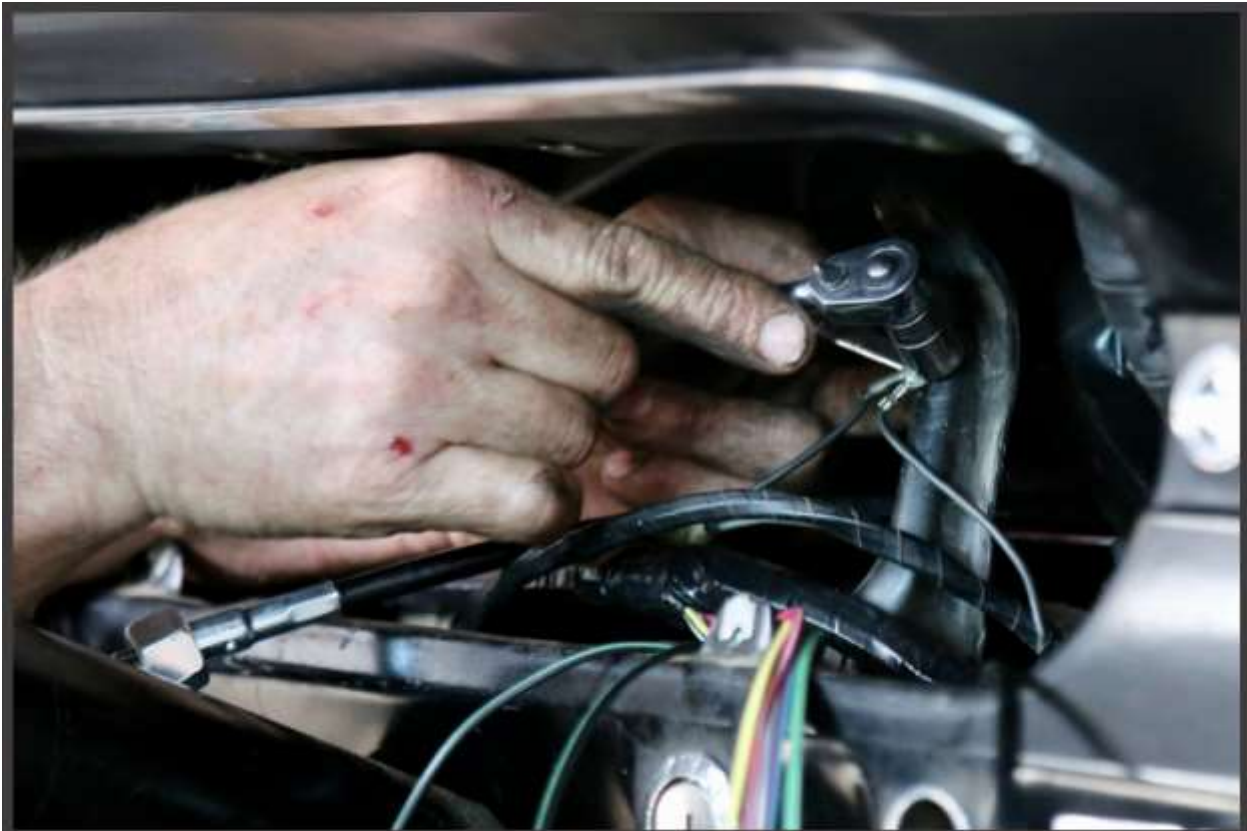
The ground wires are secured with a new fastener.

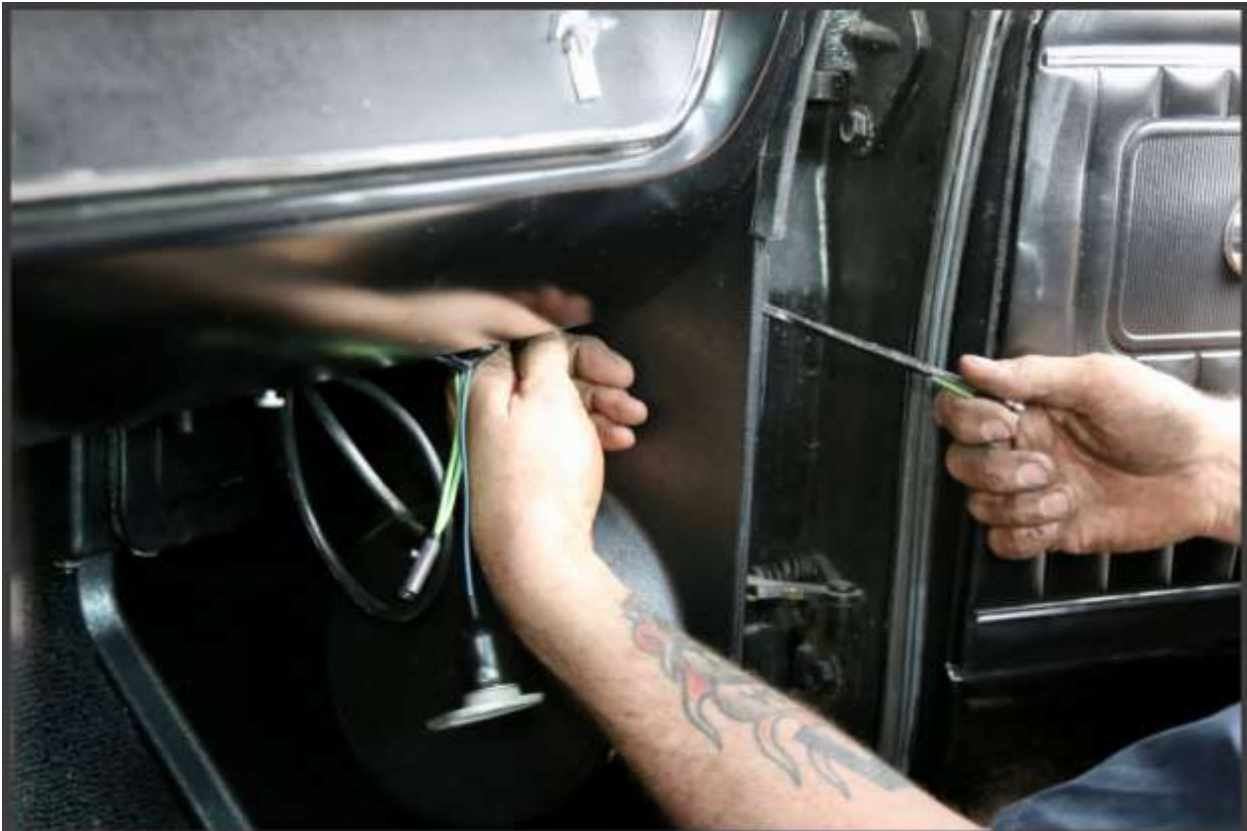
Under the right side of the dash, the speaker and door jamb dome light switch are connected, and the under dash courtesy light is also installed with a new bulb.

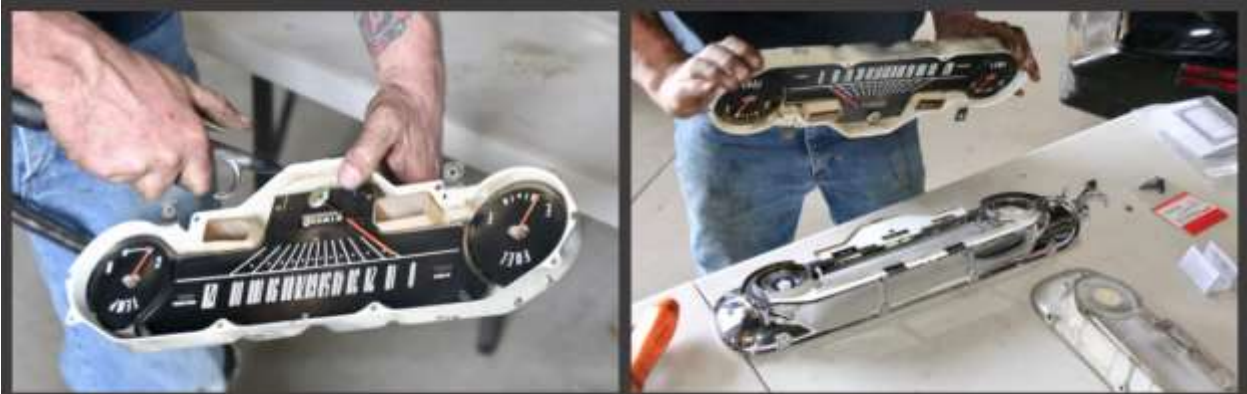
The instrument gauge is removed from the old bezel and dusted off with a light blast of compressed air before being fitted with a new bezel and lens.

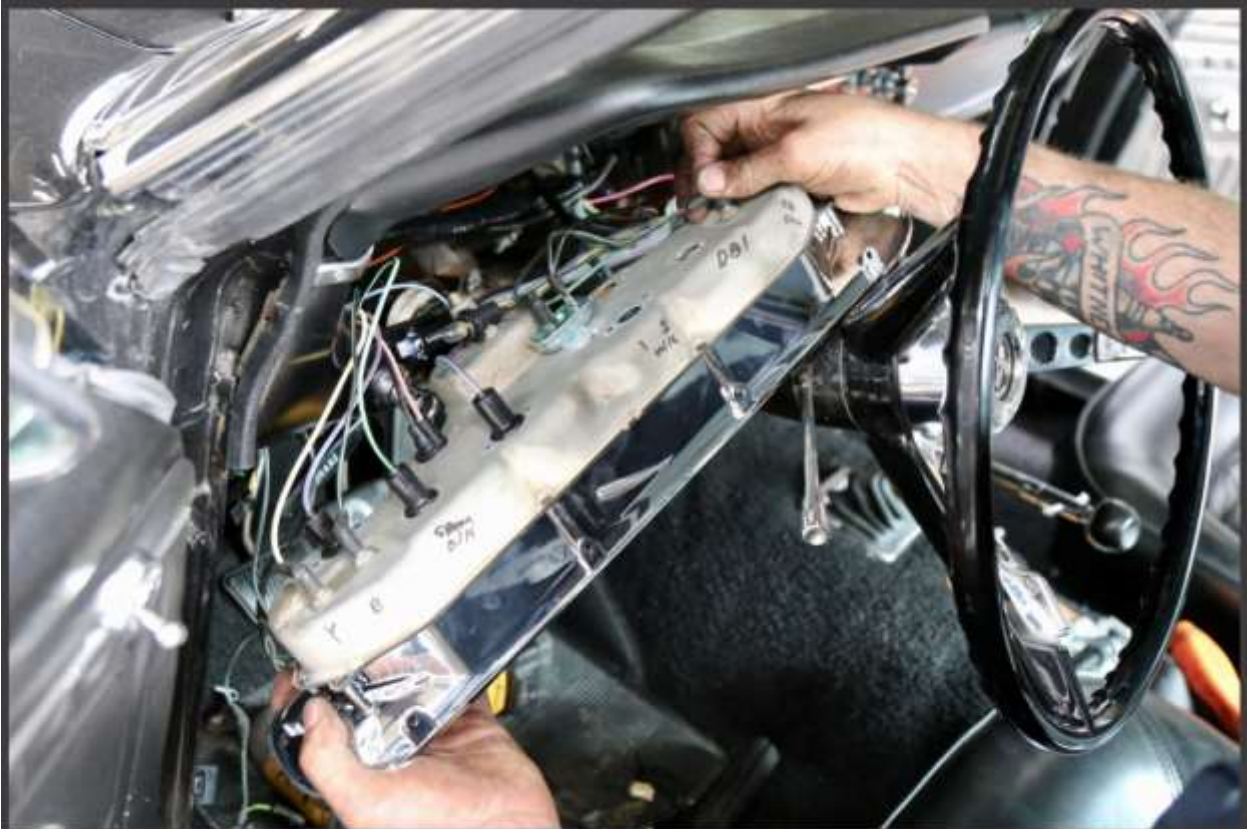
One end of a new speedometer cable and the appropriate gear were installed in the Toploader transmission before the gauge panel reassembly began. All the connections were made using the notes and wire color coding.

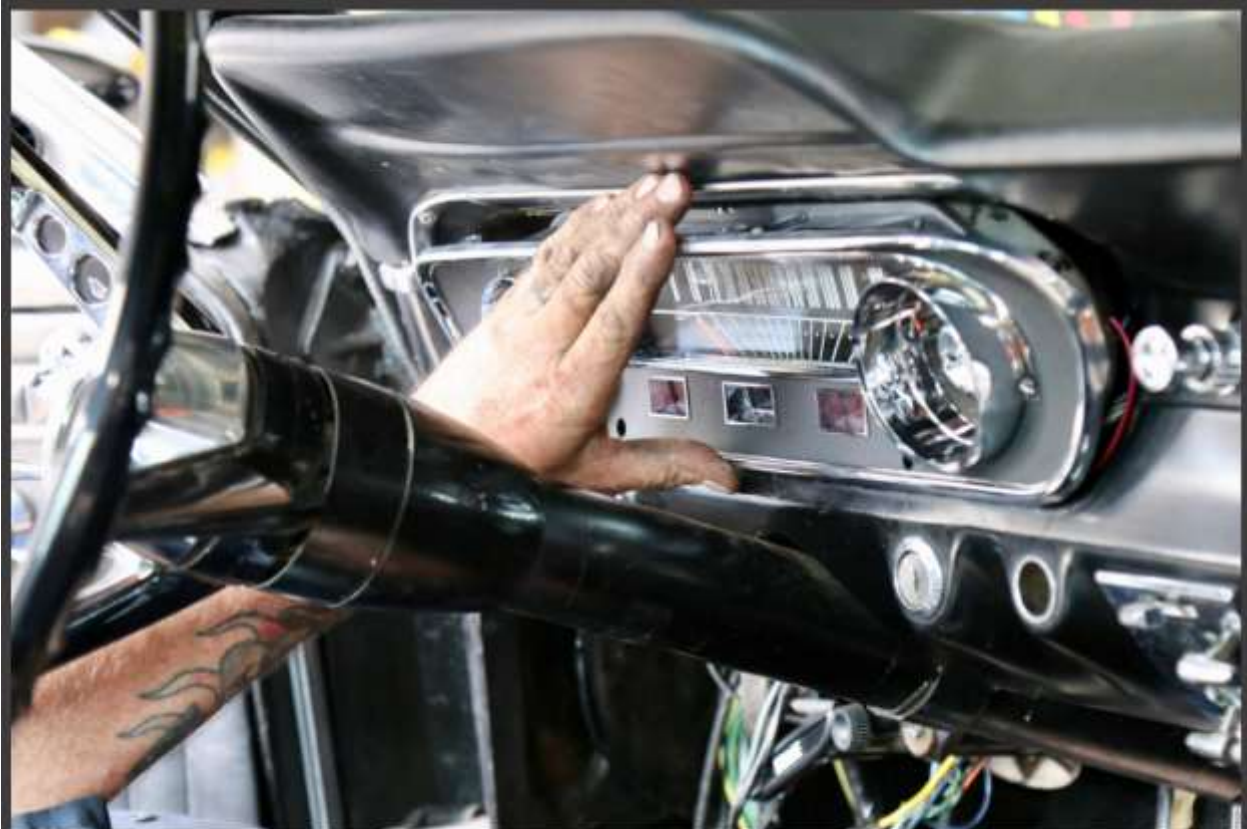
The gauge panel was positioned in the dash but not secured until a check of all the systems were conducted.

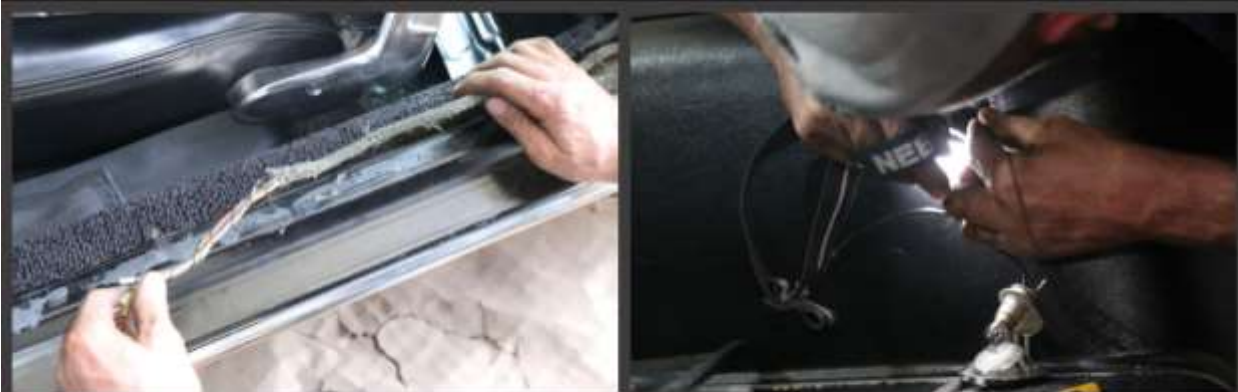
Removing the sill plate reveals the taillight harness. A "snake" needs to be attached to it, and then it's pulled from the trunk. Wiring for the two interior lamps on the fastback models also need to be snaked when removing the harness.

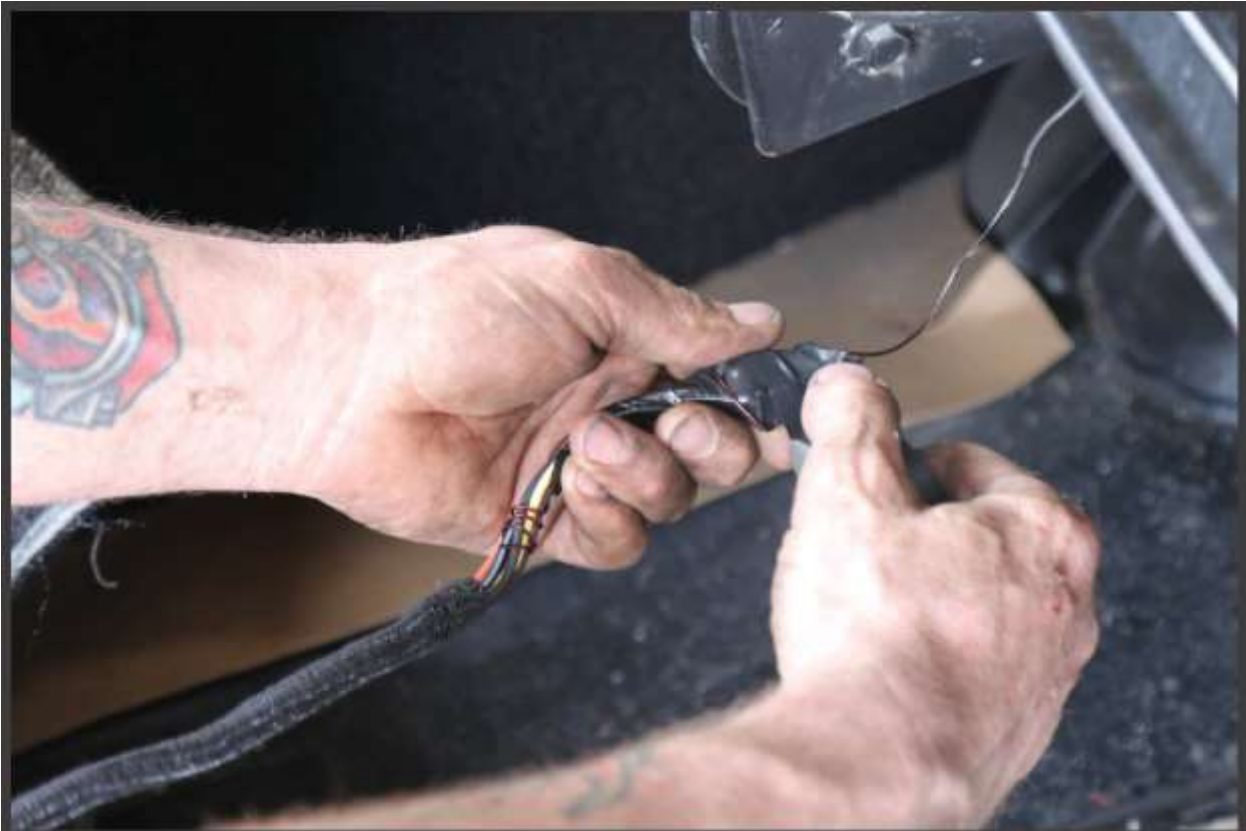
Here's the new Scott Drake harness ready to be pulled with the snake from the trunk. Once positioned, the taillights were easily connected along with the wires to the interior lamps on each side.

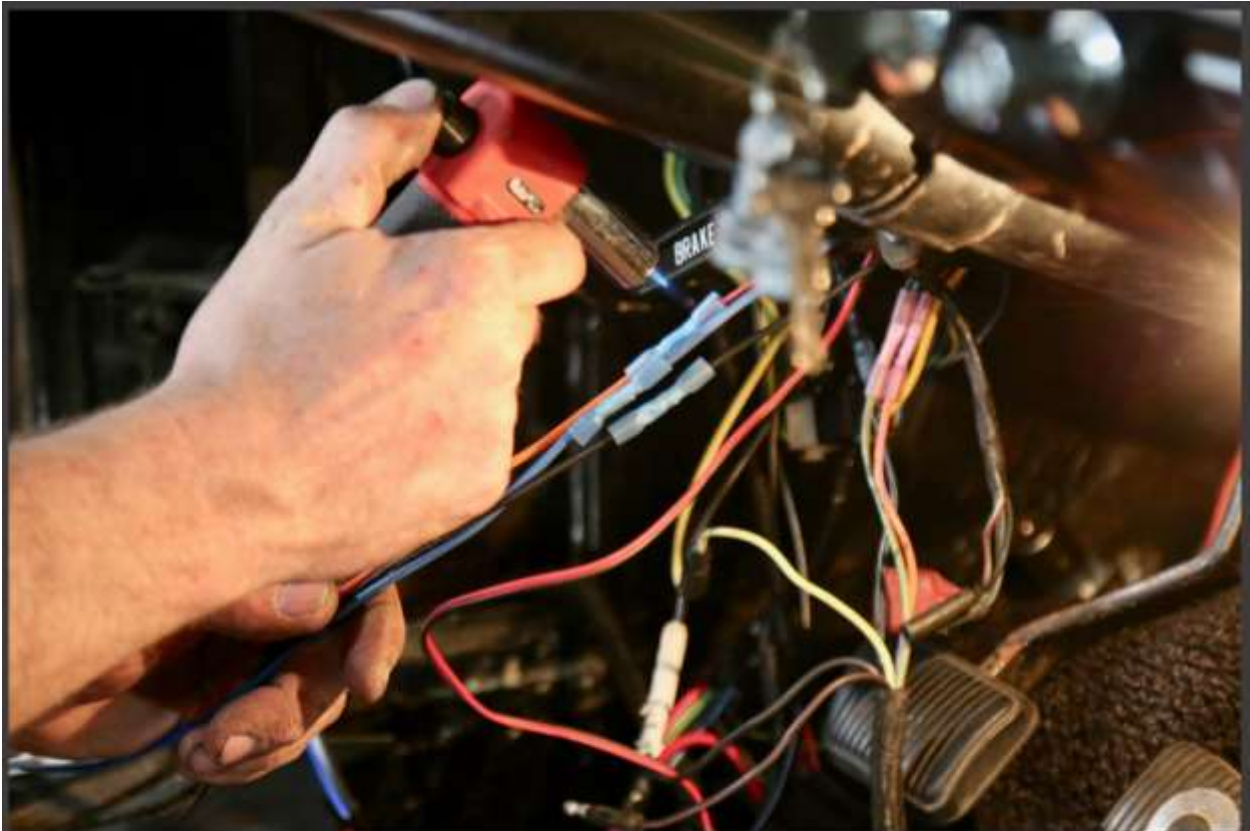
All the connections were finalized, and the insulations on some needed heat shrinking.

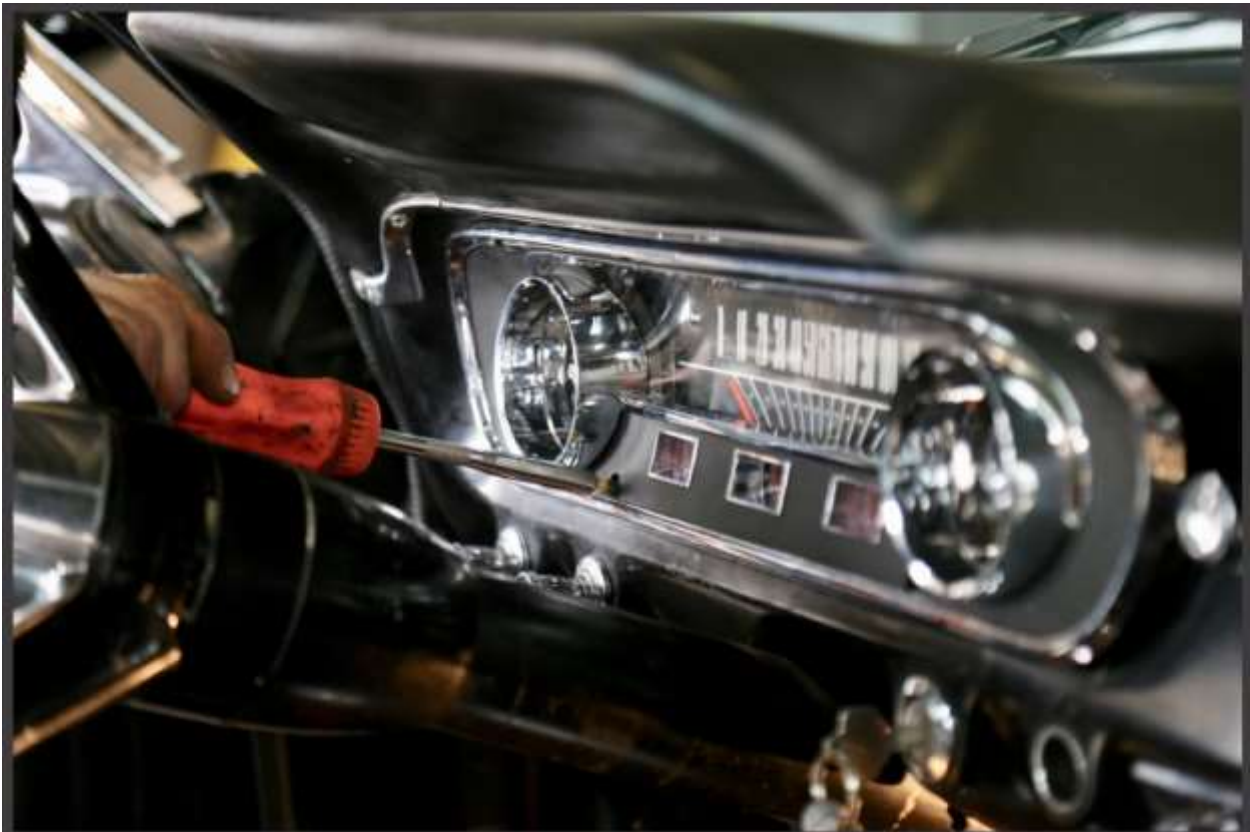
The instrument panel is secured with new hardware.

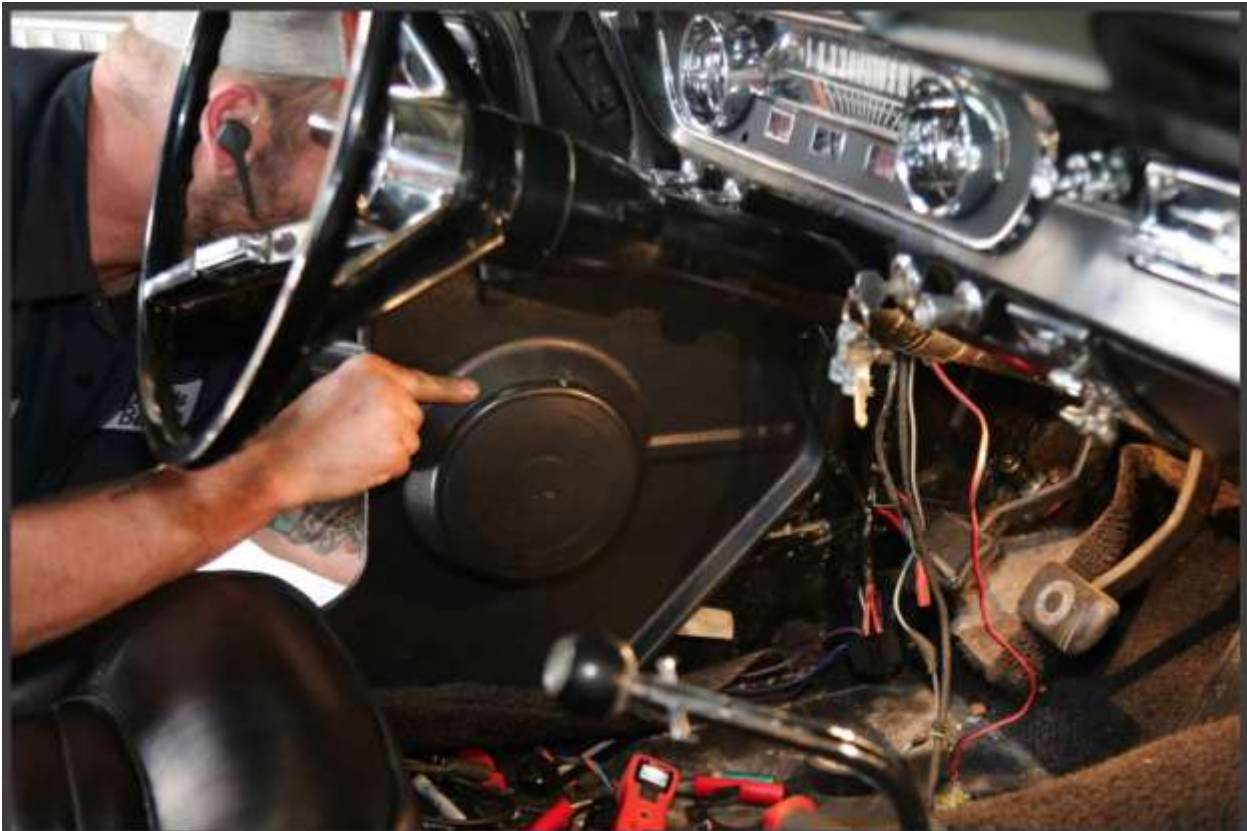
Scott Drake does provide a template to help mount the fuse panel, but it didn't work with the speakers. So, when the kick panel was replaced, the fuse panel was mounted to it near the stock location just above the speaker. Any loose wiring was wrapped with electrical tape and tucked up safely under the dash.

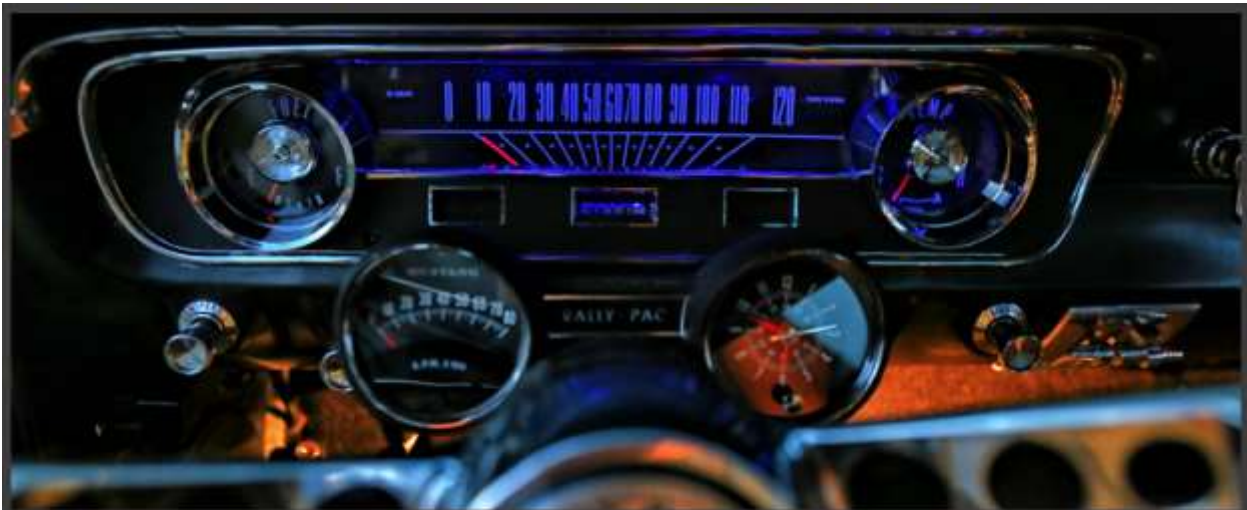
The final step was to install the Rally Pac cluster and to see the fruits of our labor, all lit up. The looks are great, but knowing that fresh wiring had replaced the old, brittle original equipment is the better part of this swap.
